**Allegany College of Maryland**  
**12401 Willowbrook Road, SE, Cumberland, MD 21502-2596**  
**WORKFORCE TRAINING & DEVELOPMENT CENTER**

Allegany College of Maryland is soliciting architectural and engineering services for the design of capital improvements and renovation of the Workforce Training & Development Center (19,971 square feet), which was constructed in 1978. Comprehensive capital improvement/renovation will be completed in a single project over an estimated 18-month period.

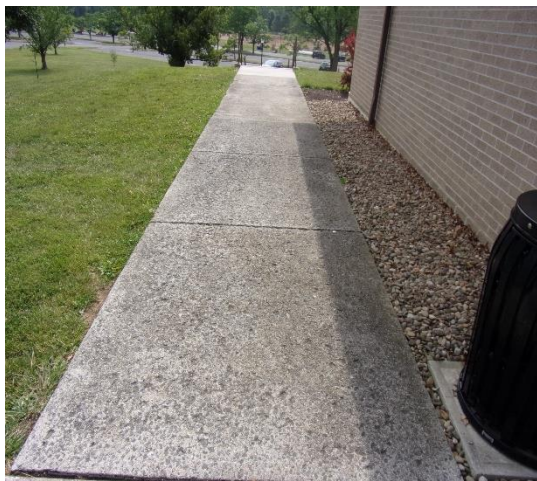
The Workforce Development and Training Center is located on a site level at the front side with gentle slopes at the building end and an embankment of the small level area at the rear of the building. There is

space for limited expansion at the ends of the building, but this is not a highly desirable option for expansion. The sidewalk at the north end of the building is severely deteriorated. The six flights of stairs and the sidewalks at the east side (rear) of the building are severely deteriorated. These provide the general path to a contiguous parking lot, which provides ample, undesignated parking for the Center and other surrounding buildings. An accessible route does not exist and is cost prohibitive due to the elevation change and need to keep overall project costs reasonable. Designated handicap parking is limited directly in front of the Center's main entrance. The Center is used throughout the week and weekend as well as for evening training. External public transportation companies use the site for a

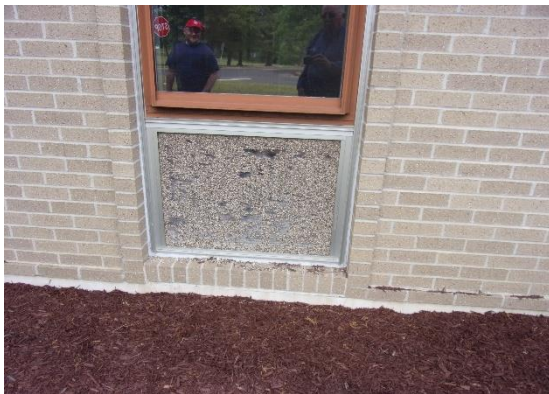
The built-up standing seam metal roof system is near the end of its life cycle. The roof fascia and soffit system has deteriorated. The brick chimney is deteriorating. The exterior shell presents an outdated façade. Exterior brick veneer walls are in good condition. Brick veneer requires mortar joints repair on an estimated 10% of the exterior shell, mostly at levels within 24" of the ground. Windows are single pane, non-insulated glass, which are in fair condition for their age although the composite panels under the windows have signs of severe weathering. All steel doors show signs of deterioration.

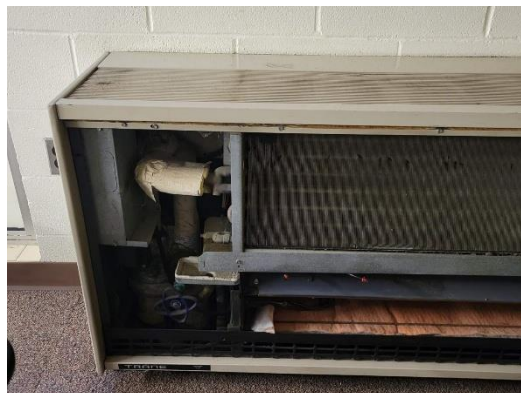
The building is heated with three (3) natural gas fired boilers that were installed around 2019. These boilers are in excellent shape and distribute heating water throughout the building to all perimeter mounted unit ventilators and the central heating and ventilating air handling unit. The 2-base mounted hot water pumps were also replaced during the 2019 project and also appear to be in excellent condition. It appears that when these boilers were installed, a new

building direct digital control (DDC) system was installed. This system should provide the capability to connect future HVAC equipment to it, allowing equipment to be controlled by an automated site-wide building management system (BMS). A total of 20 cabinet-type unit ventilators, which provide heat and ventilation to the classrooms, are installed around the perimeter of the building. These unit ventilators are reported to be fully

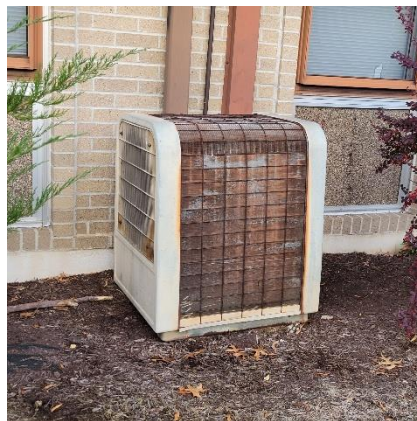
functional but are original to the building, and well beyond their expected useful life. A typical example of an existing ventilator is pictured to the left. Ventilators are equipped with pneumatically actuated fresh air dampers. Heating water is distributed to these unit ventilators through a piping trench which was constructed beneath the floor. There was no way to gain access to this piping trench at the time of the assessment, but based on discussion with maintenance personnel, piping has not experienced any known leaks and is believed to be in good condition. Conditioned air flowing into classrooms is delivered by a mismatched network of 12 individual split air conditioning systems. These systems vary from 2 to 5 tons of cooling capacity and typically provide cooling for 1 to 3 classrooms. The units range in age from less than 1 to over 30 years old. Fifty percent (50%) of the systems are well beyond their expected useful service life and experiencing deficient performance and increased energy consumption. At the time of inspection, one was observed to have the coil frozen up, which is an indication of a system leak or similar condition that would require servicing. The unit pictured above is representative of general deterioration and condition. A central mounted air handling unit provides heating and ventilation throughout the interior core of the building. This unit was replaced in approximately 2019 and appears to be in excellent condition. There is a large inline return air fan that is installed in the air handling unit room, which is original to the building and no longer functional. It was not immediately clear if this fan is still intended to operate in coordination with the new air handling unit or if this fan's functionality was incorporated into the air handling unit itself. In either case, it is recommended that the return air fan be either replaced or removed.
